The Use of the EZDebride Wound Instrument for Surgical and Wound Care Staging in a Combat Mine Explosive Foot Injury

Abstract: This is a presentation of a Ukraine Soldier who underwent limb salvage procedures including surgical debridement and external fixation secondary to a severe ballistic injury to his left lower extremity. The patient presented with a large wound of the lateral rearfoot, devitalized tissue, and comminuted fractures. **Methods:** The EZDebride Wound Instrument was utilized throughout the perioperative, post-operative, and multi-modal care treatment phases which included the use of negative pressure and a split thickness skin graft to determine its efficacy in a complex trauma and wound care presentation. **Conclusion:** The author found the EZDebride Wound Instrument to be extremely effective in the debridement of the devitalized tissue and wound bed preparation for advanced wound technologies including negative pressure and a split thickness skin graft application.

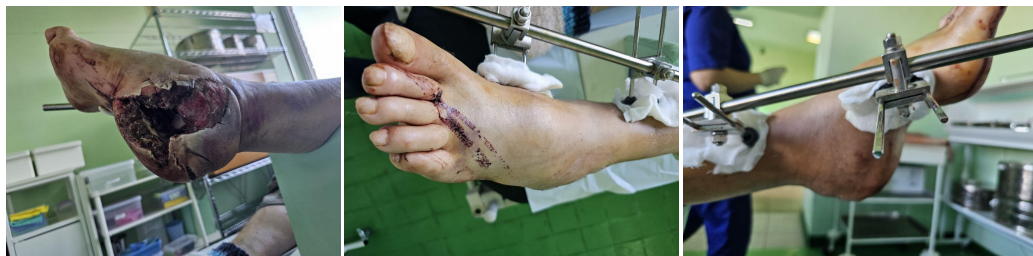
Status Post Day 4: dressing removal, EZDebride Sharp Debridement: Negative Pressure

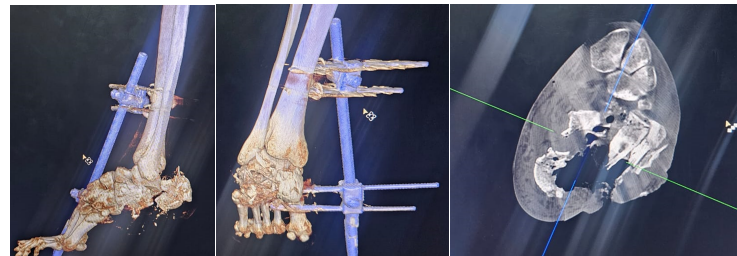
CT Scan: fragmented calcaneus, distal tibial fx, cuboid and metatarsal fxs, multiple soft tissue defects

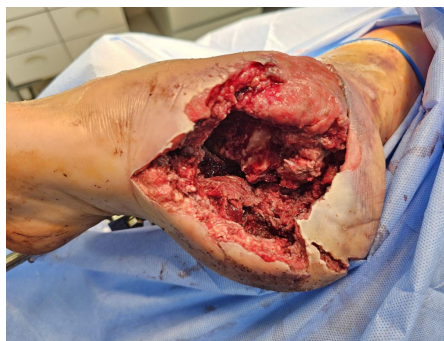
Negative Pressure Removed
Status Post Day 7

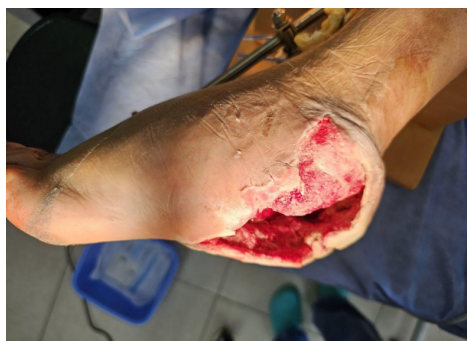
Wound Bed Preparation S/P Day 7: EZDebride Sharp Debridement

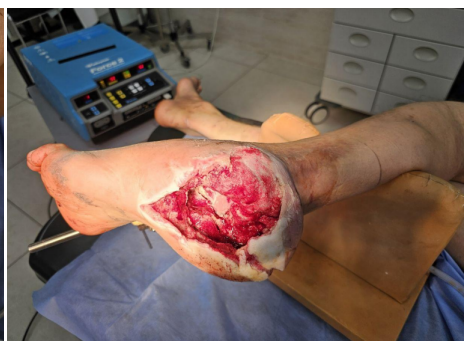
S/P Day 14

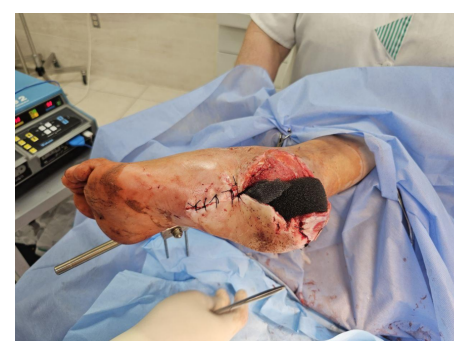
S/P Day 14: EZDebride

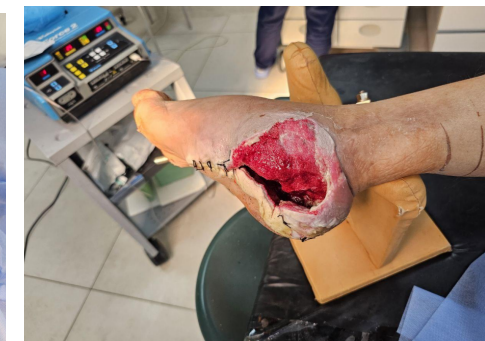
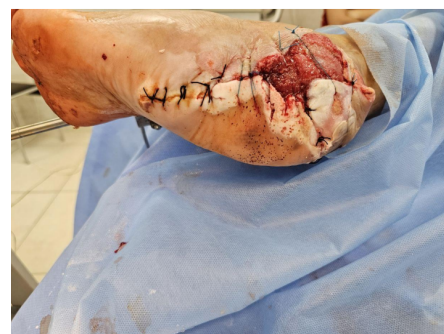
S/P Day 14: EZDebride Sharp Debridement: Retention Sutures

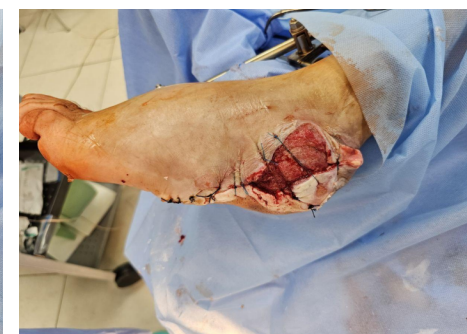
S/P Day 21: EZDebride Wound Bed Preparation: Graft Application

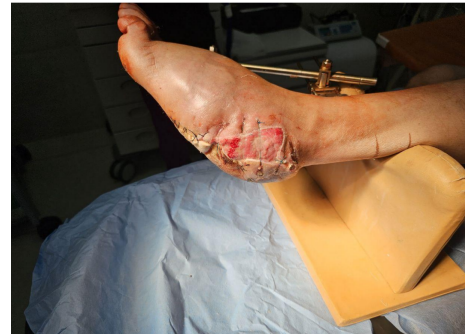
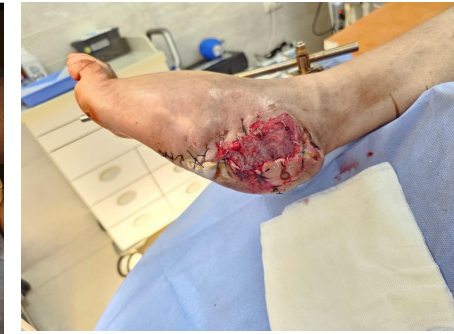
S/P Day 24: Dressing Removal
